Area in Need of
Redevelopment
Investigation

White Township Plaza
Block 53, Lot 1
525-551 US Route 46
White Township,
Warren County, New Jersey

Report prepared on **September 9, 2022**
Adopted by White Township Planning Board on _____
Adopted by White Township Committee on _____

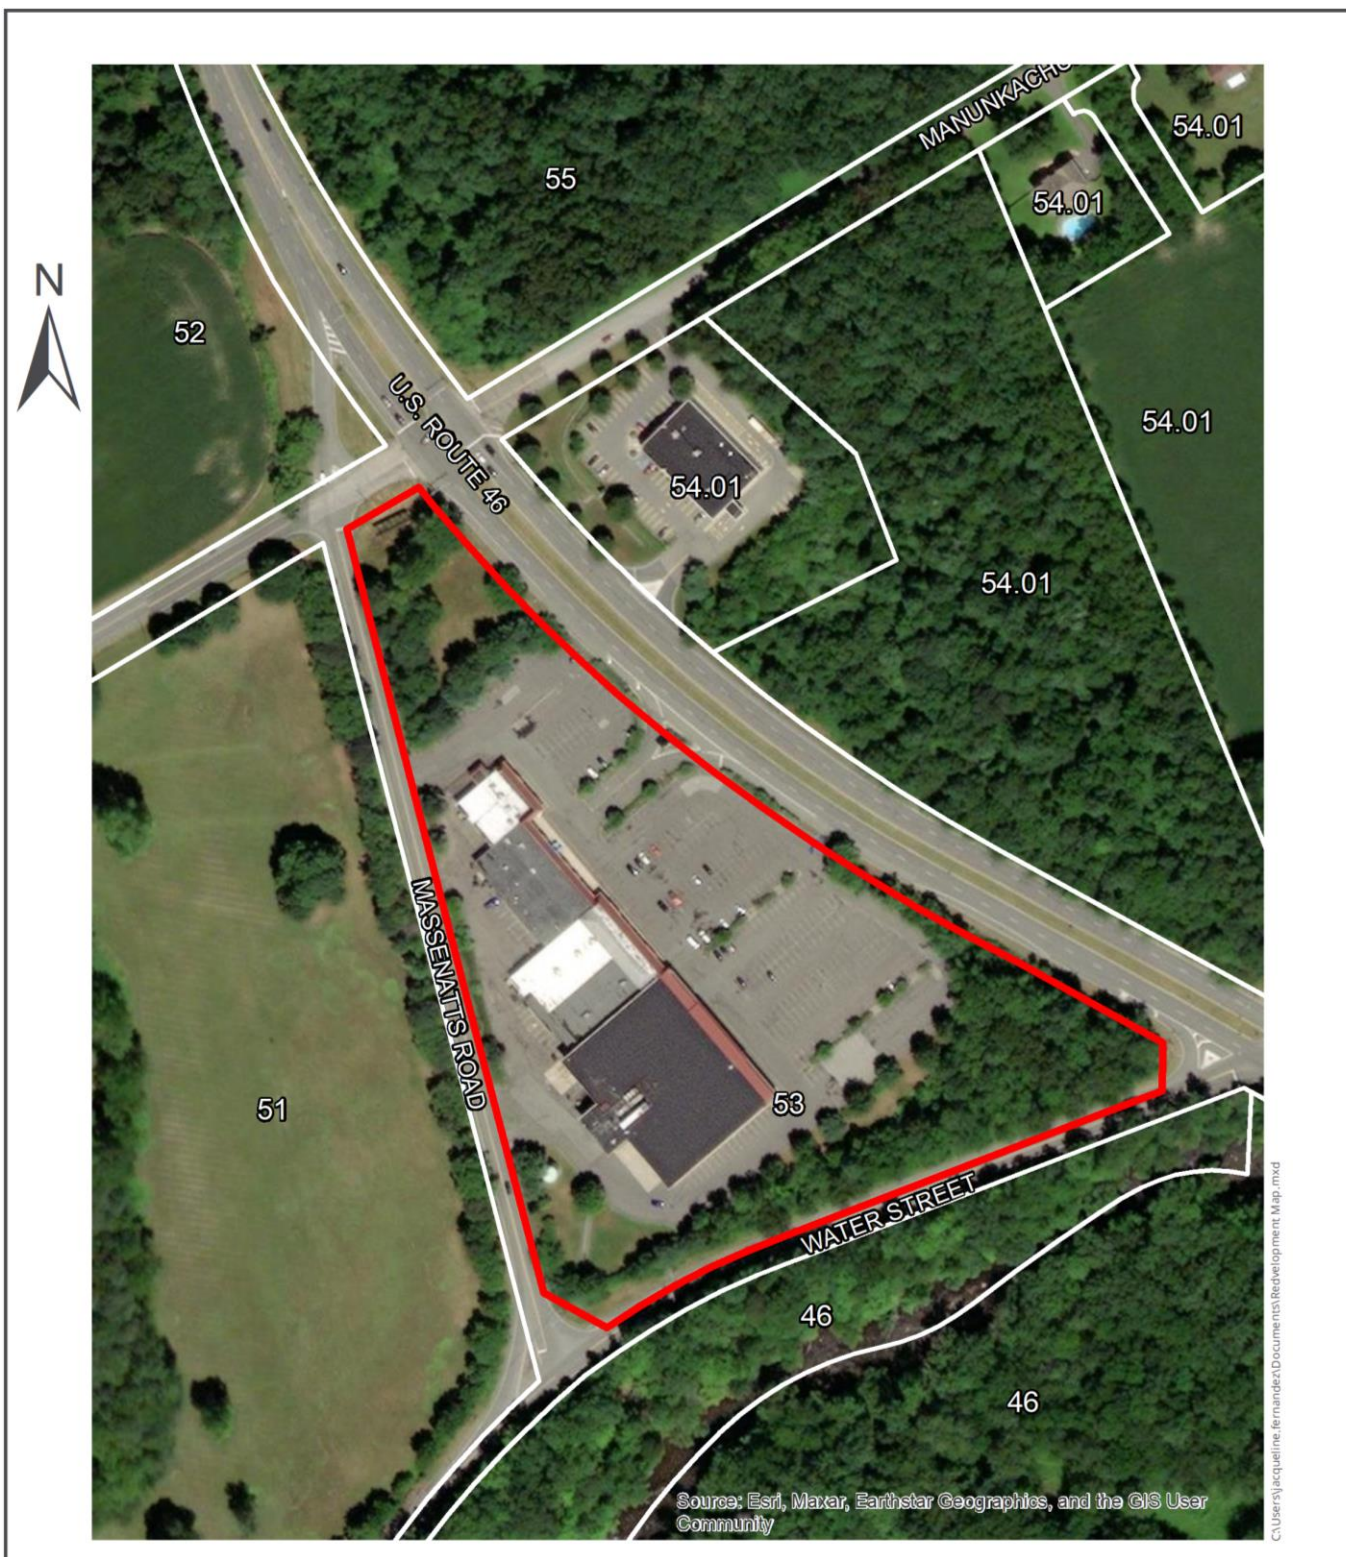
Map 1: Study Area Map with 2020 Aerial Photograph

<p>0 100 200 300 400 Feet 1 inch = 218 feet</p>	<p>Study Area Map Redevelopment Investigation Block 53, Lot 1 White Township, Warren County, New Jersey</p>	<p> Colliers Engineering & Design June 2022</p>
---	---	--

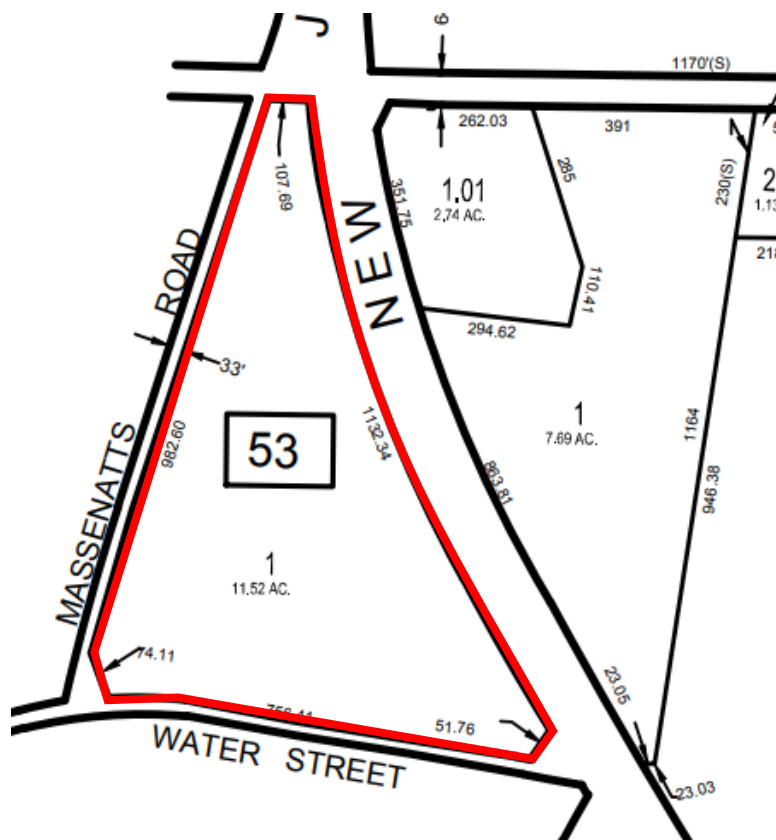
Map 2: Excerpt of Township Tax Map with Study Area Outlined

The study area consists of Lot 1 in Block 53 and is located along US Route 46. The study area contains approximately 9.25 acres. As illustrated in **Map 2** below, the lot is a triangular parcel with road frontages on all sides, including Water St, Massenatts Road, US Route 46, and Manunkachunk Road. The property is generally isolated, with only a freestanding Rite-Aid to the north, across Route 46. To the east, across Water Street, is the Pequest River. To the west, across Massenatts Road, is a religious convent on over 76 acres of undeveloped land. To the west, across Manunkachunk Road, is a 250- acre industrial complex for DSM Nutritional Products. The study area contains a retail strip mall with vehicular entrances along Massenatts Rd and right-in/right-out access to US Route 46 eastbound. The property is within the sewer service area of and is served by the Warren County (Pequest River) Municipal Utilities Authority.

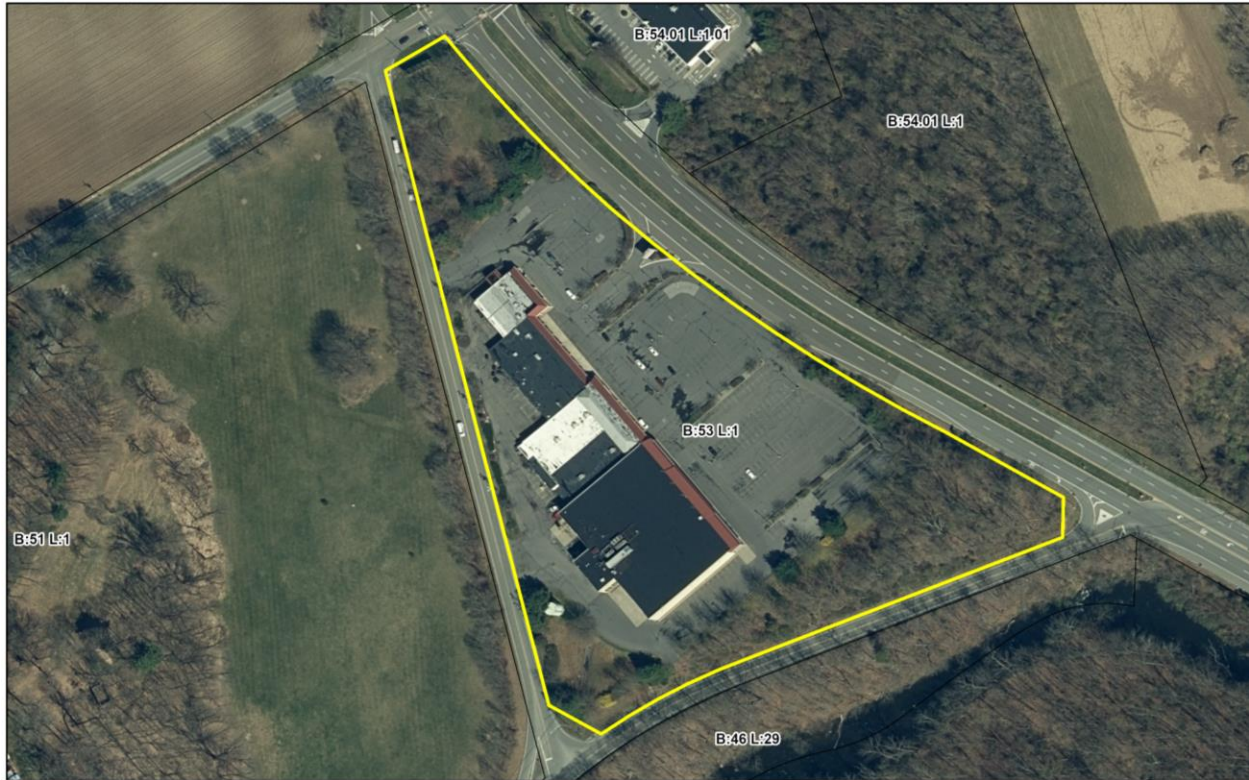
Map 3: Aerial Photograph of Study Area, 2020 (via NJ Highlands Council Interactive Map)

Lot 1 in Block 53 is a 9.25-acre (402,930-square foot) parcel developed with a 72,000-square foot strip mall on the property known as White Township Plaza. The property contains 380 parking spaces with an area reserved for future construction of 43 additional spaces as needed.

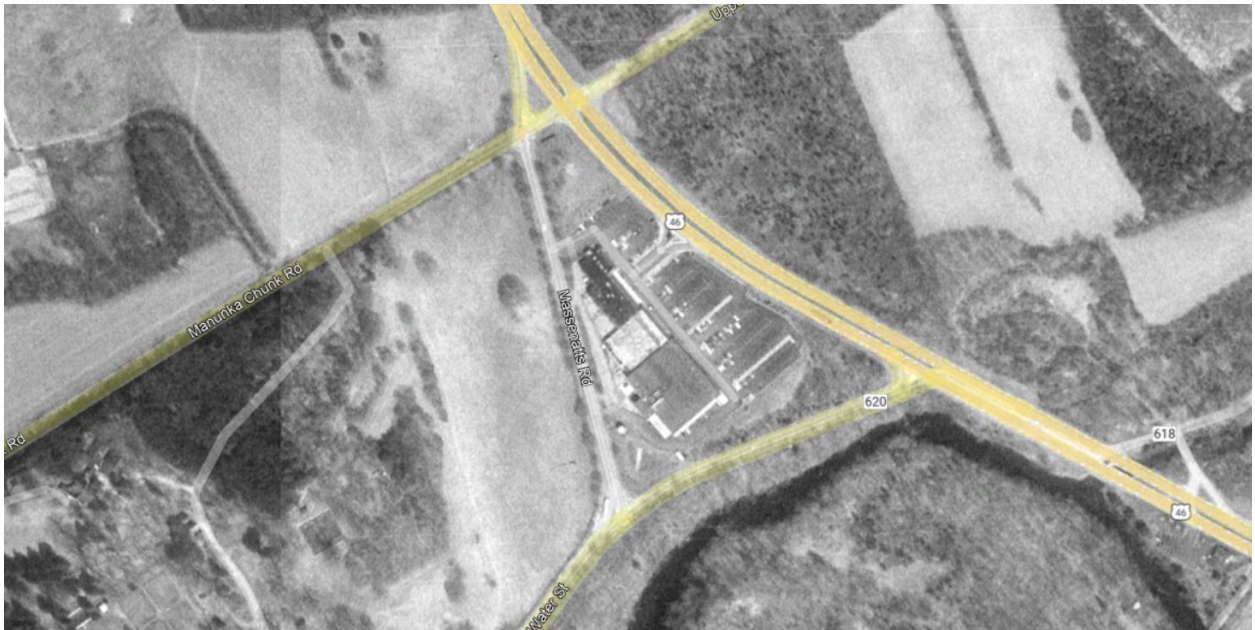
Map 8: Aerial Photograph of Study Area, 1992 (via GoogleEarth)

Map 8 shows aerial imagery from 1992 with the final addition completed for the A&P Food Store.

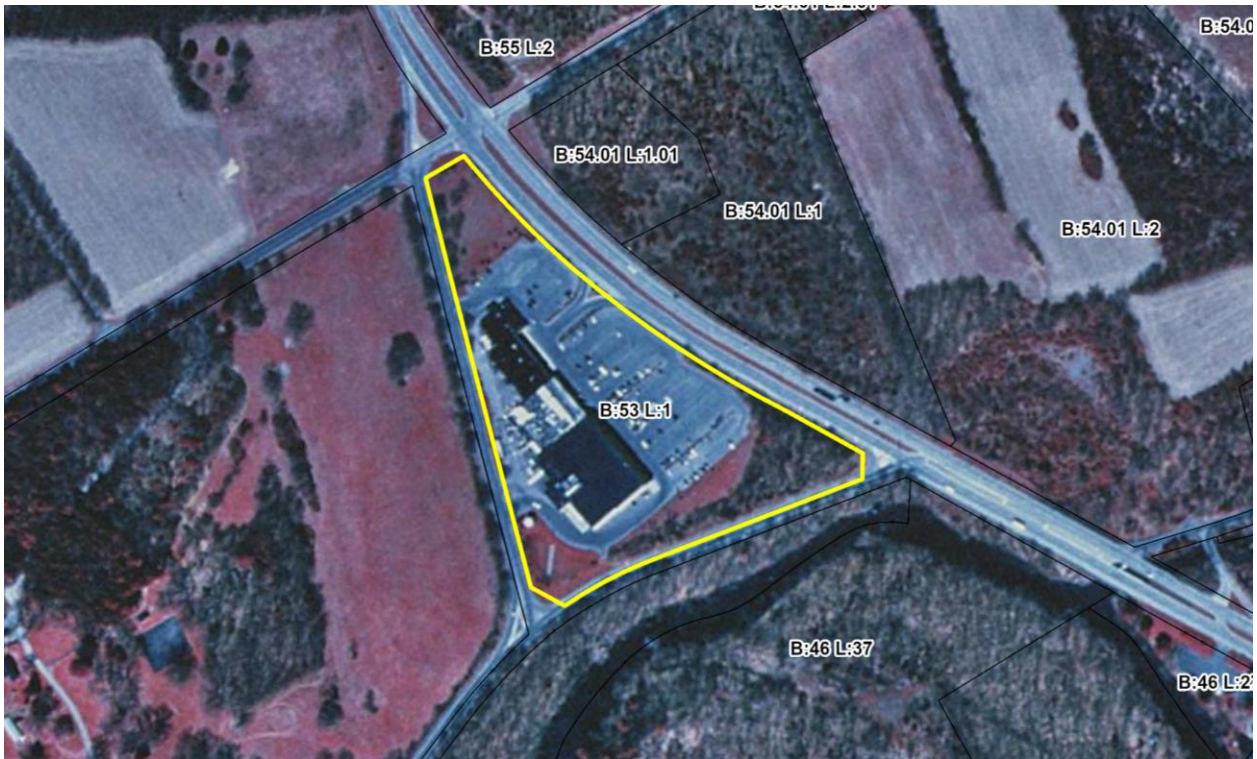
Map 9: Aerial Photograph of Study Area, 1995 (via NJ Highlands Council Interactive Map)

Map 9 shows aerial imagery from 1995 and **Map 10** shows imagery from 2012. Both maps show the building and parking configuration as exists today. The parking lot appears to be less than 25 percent utilized in both aerial photos.

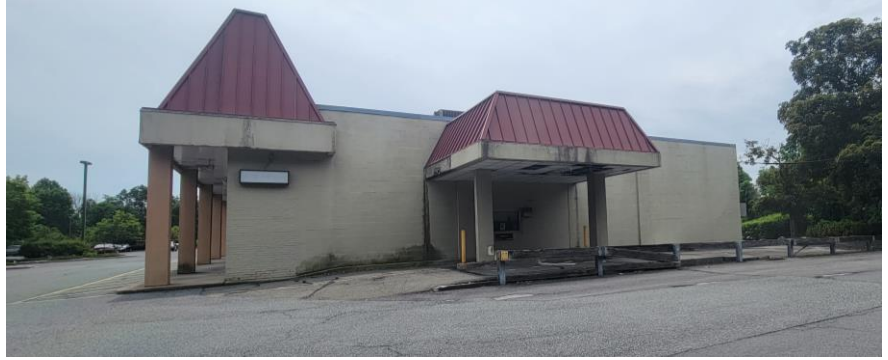
Photo 1: Exterior of Bank and Drive-Thru

Evidence of damage, degradation, and general neglect was found around the exterior of the property and throughout the building's interior. **Photo 1** shows the exterior of the former bank with the now defunct drive-thru window. The walls are stained with mildew and algae. There are building materials missing as they have fallen off over the years and not been repaired or replaced. The wooden guiderail is falling down due to rotting wood.

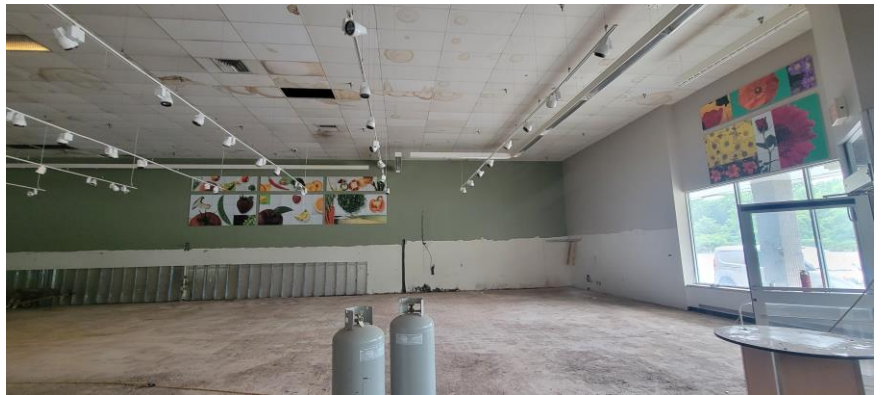
Photo 2 – Anchor Space under Renovation

Damage to the ceiling and insulation appears to be the major contributor effecting the anchor space and the ancillary units. **(Photo 2).**

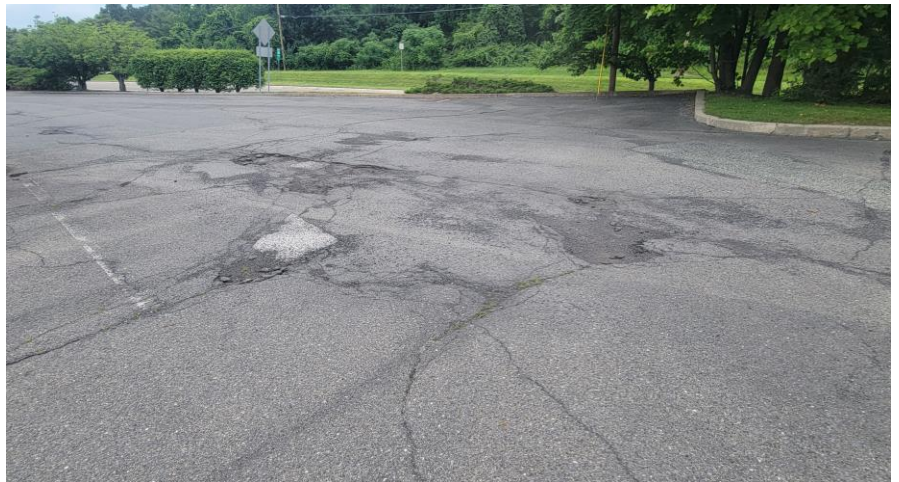
Photo 3 – Deteriorated Asphalt Parking Lot

The front parking lot is in poor condition with cracks and crumbling asphalt with aging patches. **(Photo 3).**

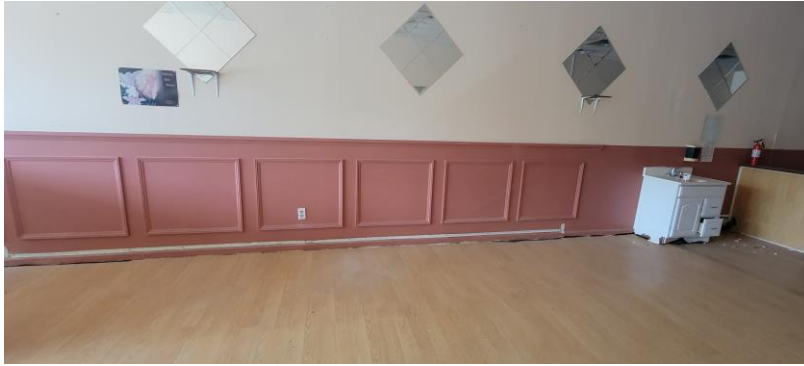
Photo 4: Interior of Former Nail Salon

There is also evidence of damaged flooring in a few of the spaces as there are gaps between the floor and wall (**Photo 4**). There was also evidence of moldy carpets based on the odor and visible water damage (**Photo 5**).

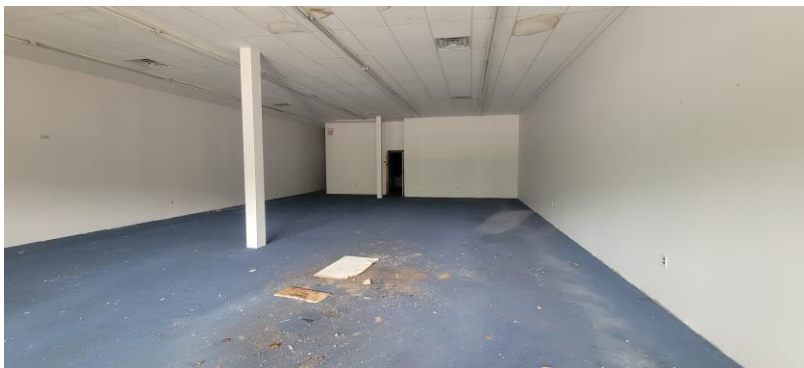
Photo 6: Interior of Former Video Rental

A few of the vacant units are carpeted and show evidence of water damage. The ceiling has also been affected by damage as a few tiles have fallen throughout the years (**Photo 6**).

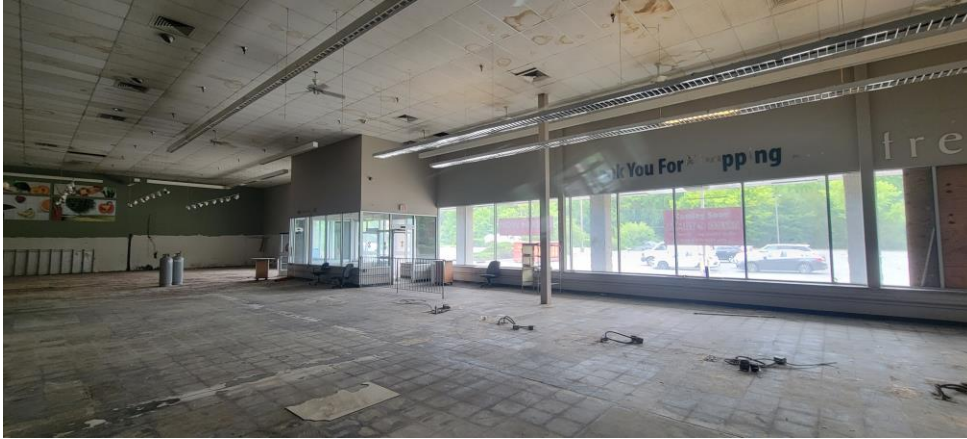
At the time of inspection, the anchor space was undergoing renovation for a new tenant fitout. The floor is in poor condition throughout the vacant anchor space with many cracks and crumbling areas, which appears to have been demolished to make way for a new floor to be installed. **Photo 7** shows the damaged floor where former pieces of equipment were removed. Piles of debris litter the floor throughout the building. **Photo 8** depicts the debris in the front of the vacant market space.

Photo 7: Interior of Anchor Store under renovation

Photo 8: Interior of Anchor Store under renovation

Photo 9: Loading Docks in Anchor Store

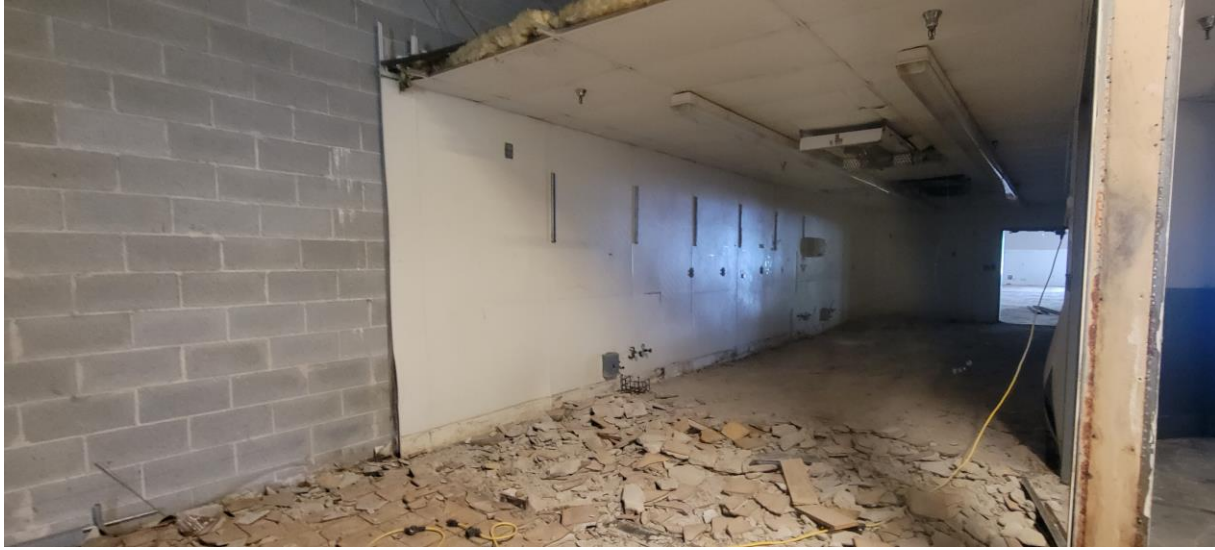
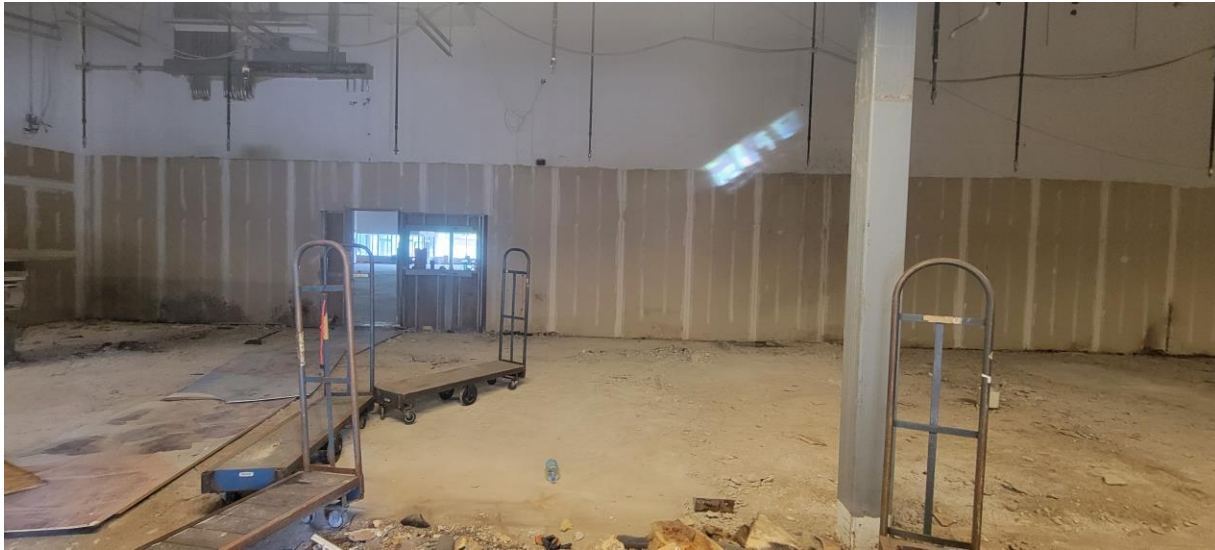
Portions of the floor in the rear of the vacant market was partially removed but the debris remained. The ceiling above was also partially removed as the installation is visible. The white wall bordering the partially removed ceiling appears to be lifting off the concrete brick wall (**Photo 10**). Water sprinklers are visible in the space leading to the loading dock. In addition to image boards and carts that were left behind (**Photo 11**).

Photo 10: Interior of Anchor Store under renovation

Photo 11: Interior of Anchor Store under renovation

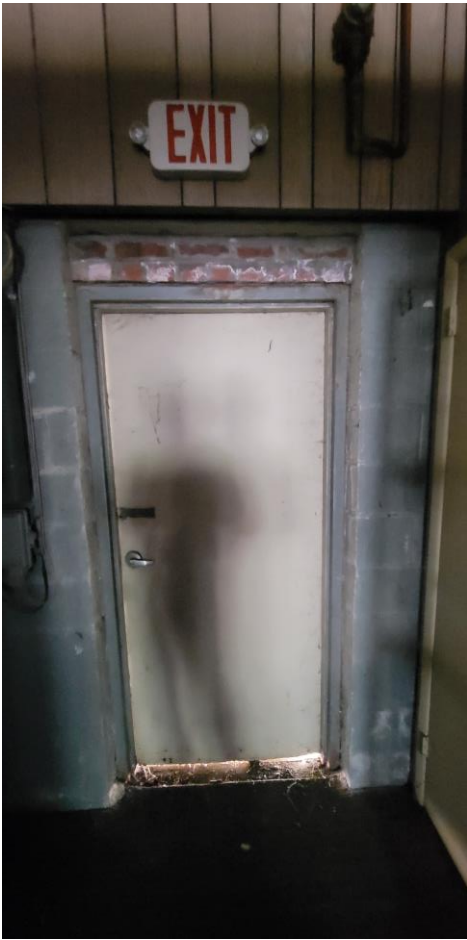
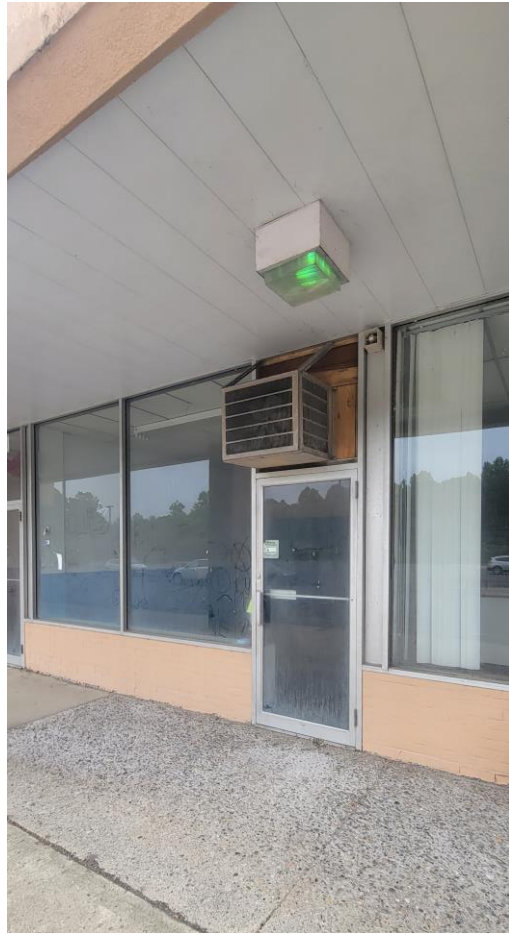
The rear of one of the ancillary spaces features an exit door that is lifted from the floor and is showing signs of degradation (**Photo 12**). The windows of this space along with a few others have words and images written in the dust alluding to one or more entrances being accessible to trespassers. As pictured in **Photo 13**, unused exterior air conditioning units are visible in the entrance ways.

Photo 12: Rear entrance to Former Dry Cleaners

Photo 13: Entrance to Former Dry Cleaners

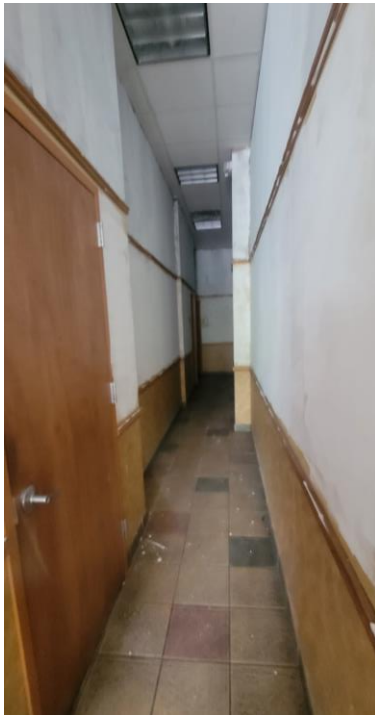
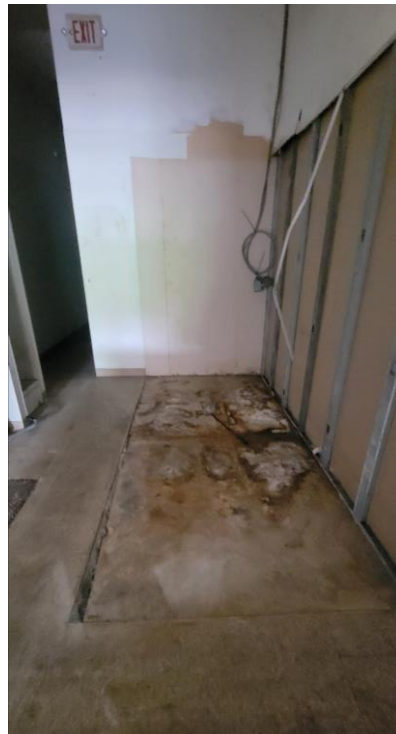
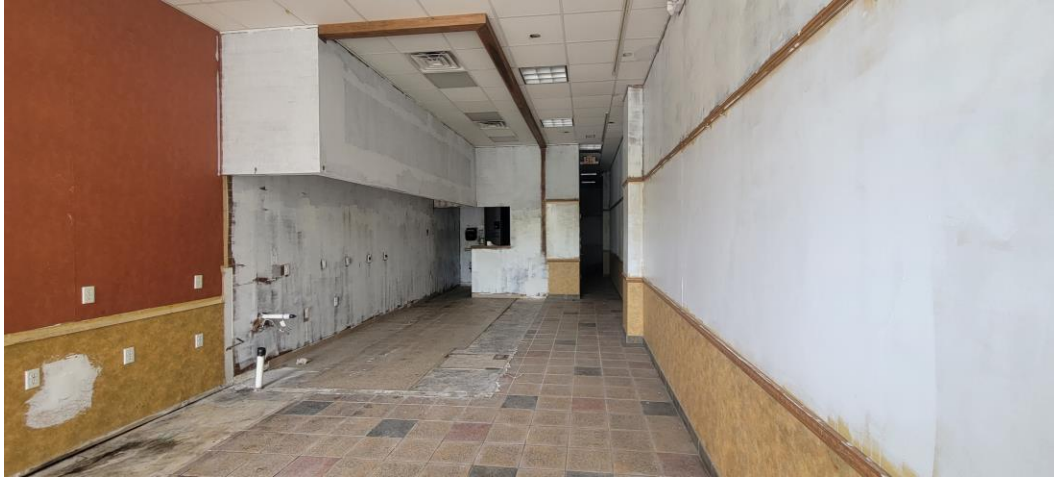
Damage from removed cooking appliances from an old Subway is pictured in **Photo 15** and **Photo 16**, along with exposed wires. There are many exposed elements that were previously used to support appliances. There is also a stain on the floor to the left due to unknown causes.

Photo 14: Former Subway

Photo 15: Former Subway

Photo 16: Former Subway

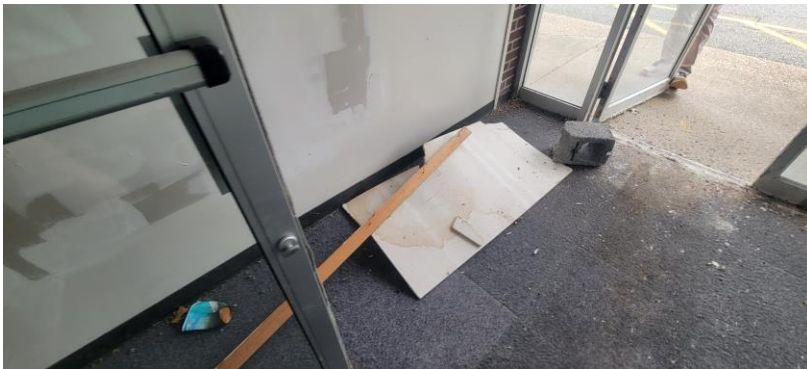
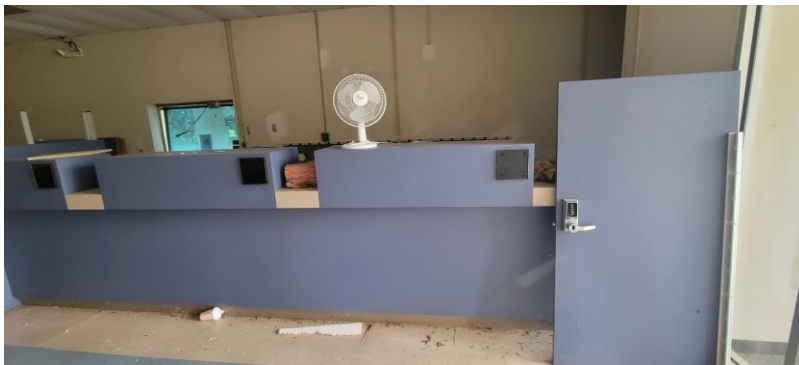
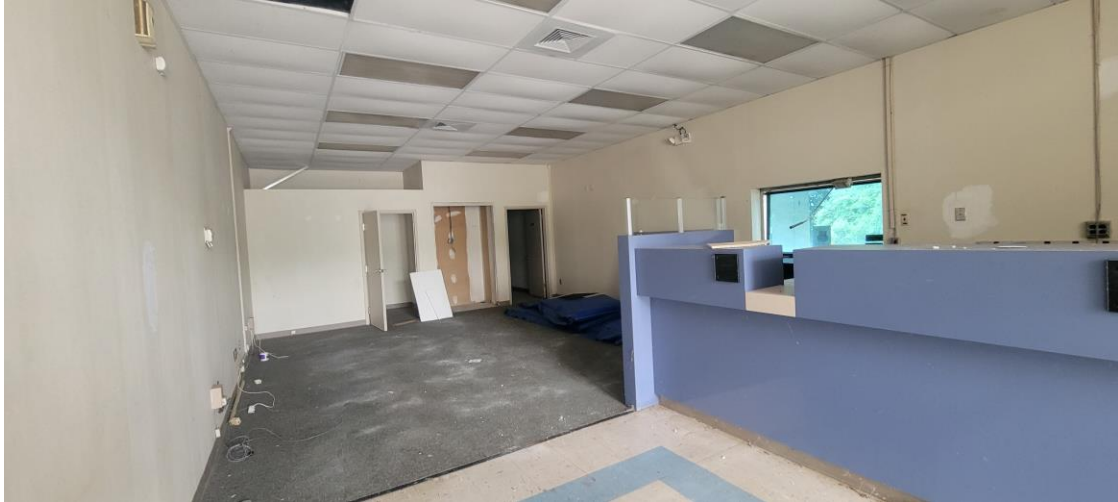
The vacant bank has debris scattered within the foyer and main office (**Photos 17-20**). Evidence of spider nests and other insect occupation are located along the walls of the space.

Photo 17: Former Bank Foyer

Photo 18: Former Bank Interior

Photo 19: Former Bank Interior

Photo 20: Former Bank Interior
